Industry – Mining Equipment Generation Manufacturer

Location	Johannesburg, South Africa
Client	Confidential
Year	2020
Application	Dissolved oil removal
Contaminants	TSS, SS, Oil & Grease
Solution	Hydramix and Hydraspin

Synopsis

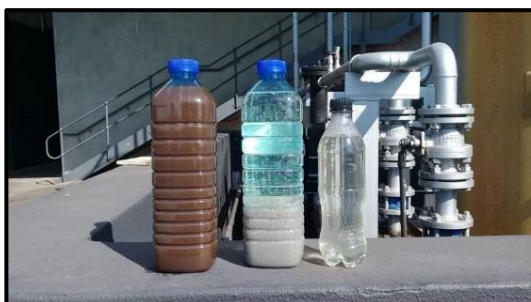
Samples were taken from the site and then lab tests were done to ensure that the Hydramix system was set up correctly for the demonstration that was done on site. Figure 1 shows the water before treatment, prior to sludge removal (middle) and after treatment, this was done with the full scale Hydramix demo unit. Figure 2 shows the water before being treated in the lab vs. post lab treatment. demo unit.

Figure 1: Before treatment, sludge removal and after removal.

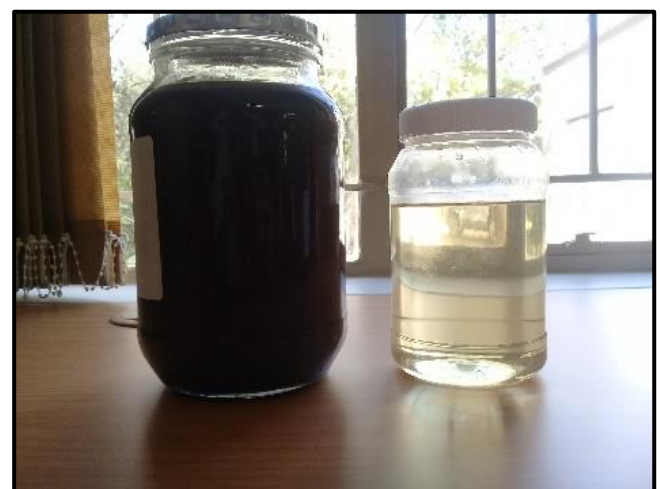
Figure 2: Before vs. After (Lab test).

***Lab results are not indicative of what the system does, only the reduction from the bench test, as an illustration as per a client request.**
