Industry – Mining

| Application | Oil-Water Treatment |
| Solution | Hydraspin & Hydramix |

Synopsis

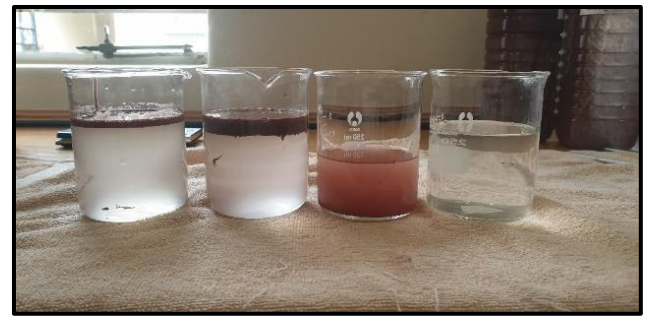
Figure 1: Visual comparison of the water

Visual results are shown in figure 1 below. From left, the first beaker shows the inlet water to the Hydraspin oil water separator, a clear layer of oil is seen on top of the water. The second beaker is the concentrated oil outlet of the Hydraspin oil water separator system, in this beaker a high amount of oil is seen on top of the water. The third beaker shows the Hydraspin oil water separator’s water outlet, here there is no visible oil on top, this water was taken as the inlet to the Hydramix CWT system. The final beaker shows the final treated water after the Hydramix CWT system, no oil can be seen, similarly no suspended solids can be seen.
